ADVANCED CERAMIC TURBINE SEAL SYSTEM, PHASES II AND III
FINAL REPORT
PWA-5426

29 NOVEMBER 1976

Contract N00140-74-C-0586

PRATT & WHITNEY AIRCRAFT

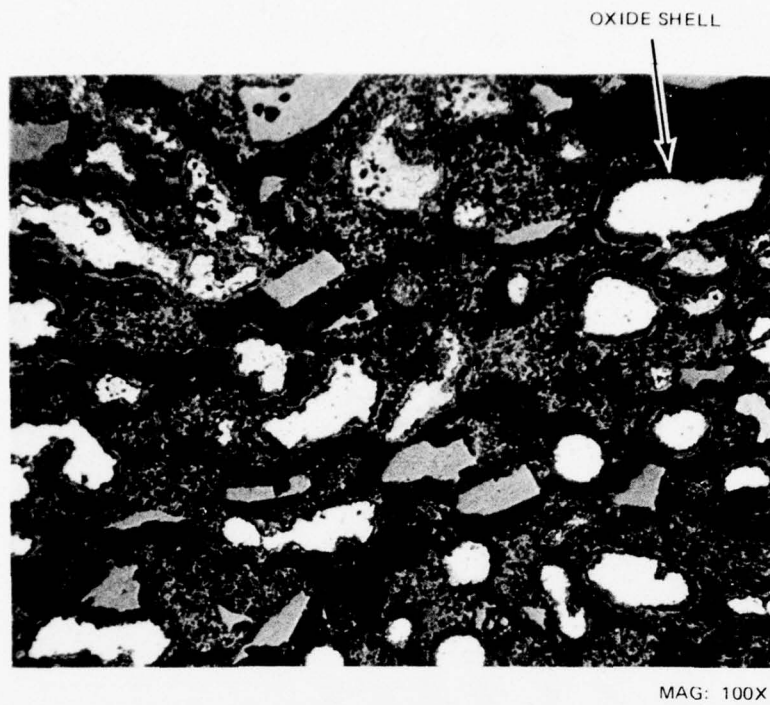
Figure 1 Thermal Shock Specimen Tested As-Built (M74164)

The excessive oxidation of the "as-fabricated", unaged specimen is characterized by a 0.2 to 0.5 mil oxide shell around the NiCr particles (Figure 1) as compared to less than 0.2 mil oxide thickness exhibited for the specimen preaged at 1800°F for 100 hours. The 1800°F, 100 hour specimen failure during aging is described in the Material Characterization section under oxidation discussion.

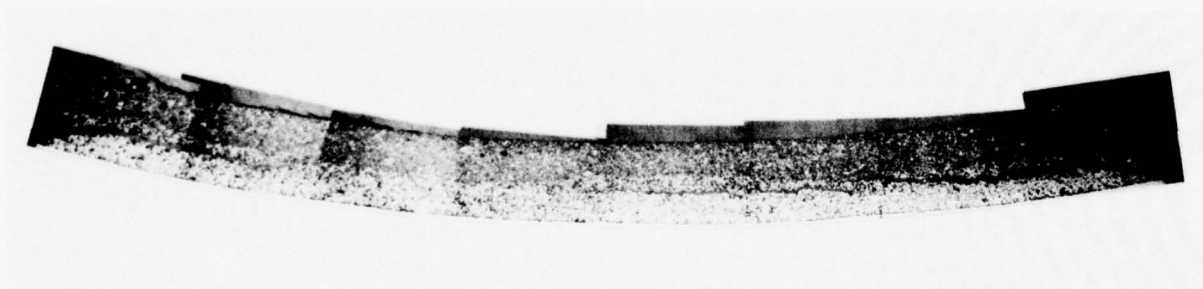
Figure 2 Metallographic Section of "First Modification" Thermal Fatigue Specimen No. 2

Metallographic analysis of "first modification" thermal fatigue specimen Number 2 was performed to determine the cause of cracks described in the Rig Specimen Testing section, page 17. Microscopic examination (Figure 2) of the sectioned seal revealed two major circumferential cracks within the intermediate layer starting at either end of the specimen extending diagonally upward toward the center of the specimen. These cracks are contained within the intermediate layer. The metal particles in the intermediate layers are oxidized above the circumferential cracks. Decreasing NiCr oxidation was observed from the ends of the specimen toward the center, in the region above the circumferential cracks. Oxidation of the NiCr metal particles also decreased from just below the ceramic layer toward the substrate but was negligible below the circumferential cracks. The distribution of NiCr oxidation indicates that the cracks were caused by thermal fatigue and that the oxidation occurred when locally high temperatures were produced above the cracks.

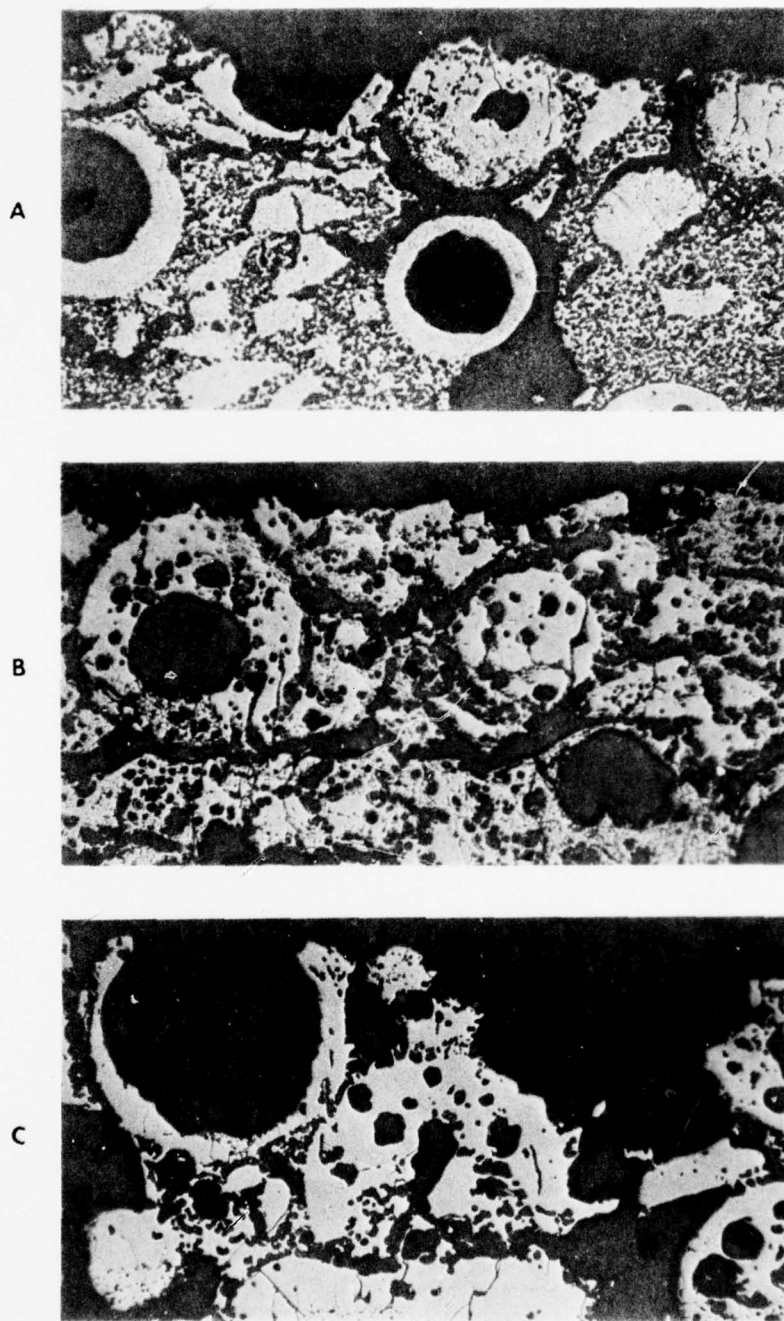
Figure 3 Microsections Near Surface of Post-Test Hot Gas Erosion Specimens: (A) 3000°F, (B) 3100°F, (C) 3200°F (M741383, M74182, M74181)

Microscopic examination of the erosion specimens shows that the degree of coalescence of the Y_2O_3 stabilized ZrO_2 matrix particles and the degradation of the CaO stabilized ZrO_2 spheres progresses with exposure to increasing temperature (Figure 3). As is evident in the post test surface photographs, (Figure 4) the degree of the crack network within the ceramic structure progresses with increasing test temperature. This cracking in the ceramic layer is considered to be caused by a combination of the shrinkage due to sintering and coalescence; and creep and plastic flow of the ZrO_2 at maximum temperature conditions causing mud flat cracks when the specimens are returned to room temperature. The surface cracks observed in the erosion specimens normally arrested in the ZrO_2 layer as seen in the microsection of the specimen tested at 3100°F (Figure 5). It can be seen in Figure 6 that the surface crack networks are mainly encompassed in the ZrO_2 matrix and that the ZrO_2 spheres act as a crack arresting mechanism.

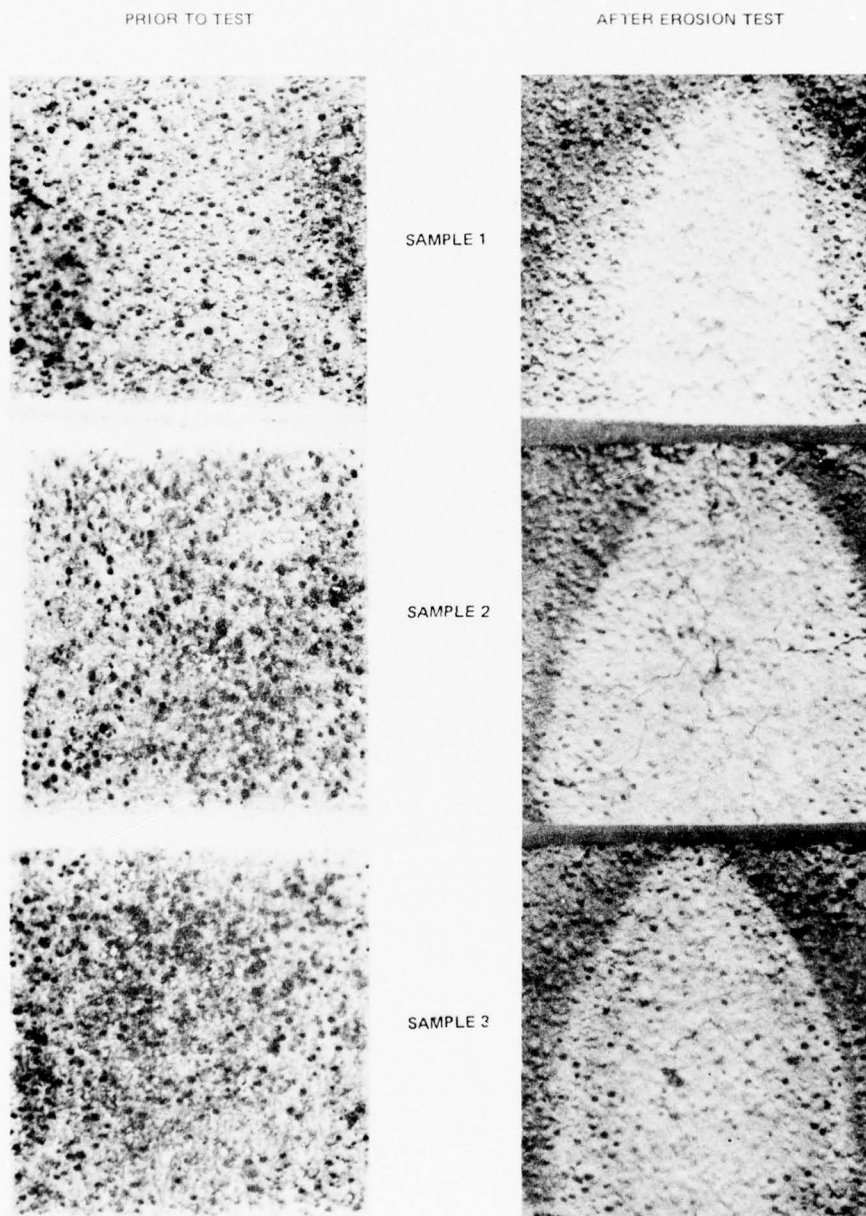
Figure 4 "First" Graded ZrO_2 -NiCr Erosion Test Specimens Before and After Test Exposure

Microscopic inspection of the erosion samples has verified that the quality from a thickness and uniformity standpoint of the "first" graded ZrO_2 -NiCr seal design rig specimens was not of the desired level. Inadequacy in graduation of the intermediate layer probably caused the laminar cracks observed in the 3000°F and 3100°F erosion specimens. These cracks existed across approximately 70% of the intermediate layer. In addition the 3000°F specimen was found to have an area void of ZrO_2 spheres which probably allowed the surface cracks to propagate to the intermediate layer interface which caused delamination cracks across 35% of the specimen.

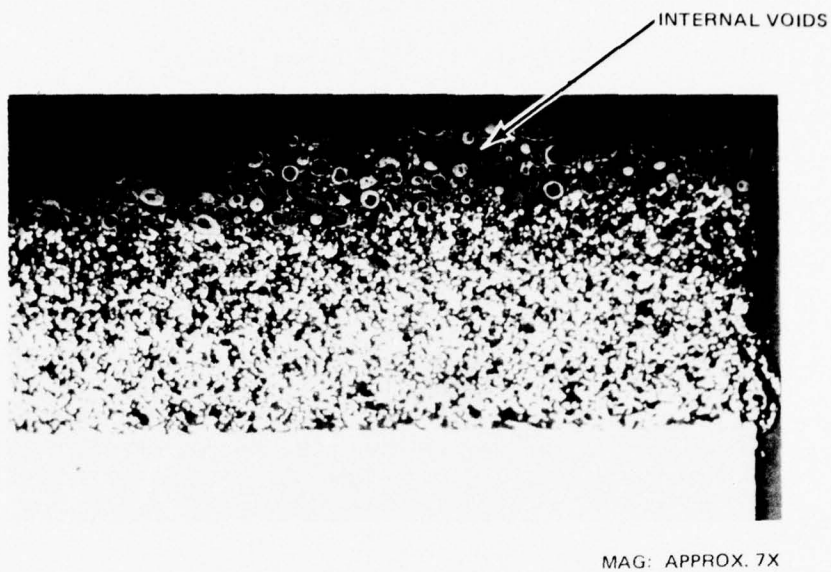
Figure 7 Microsection of "First" Rub Specimen No. 1

Macroscopic examination of the "first" test phase rub specimen Number 2 showed the characteristic grooves induced by rub of the SiC abrasive grits against the seal structure. Specimen Number 1 experienced pull out of ZrO_2 matrix and spheres over approximately 10% of the rub path. Microscopic examination of this seal specimen (Figure 7) revealed large internal voids within the ceramic layer that apparently caused the pull out of surface material upon rub.

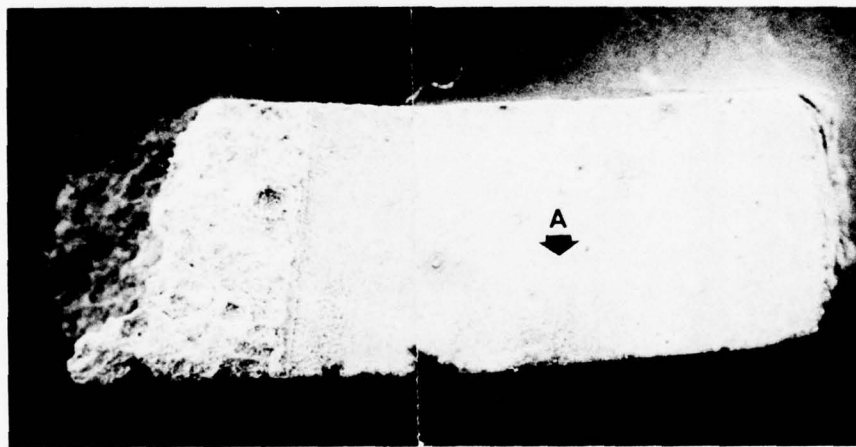
Figure 8 Section of Rub Tested Ceramic Seal Showing Rubbed and Unrubbed Areas. SEM Photograph at 19.6X

"Preliminary" rub specimen Number 3, tested at approximately 2700°F, and the SiC/M-CrAlY blade tip, which rubbed against it were analyzed. A section of the rubbed ZrO_2 seal was examined in the scanning electron microscope (SEM) and by standard metallographic techniques. The section analyzed in the SEM, Figure 8, showed typical rubbed and unrubbed areas. Within the rubbed area, a typical region indicated by A in Figure 8 was examined in greater detail, Figure 9. A generally smooth region with agglomerates on the surface was observed. These agglomerates were analyzed by dispersed x-ray analysis and was found to contain elements common to SiC, M-CrAlY and the zirconia seal material similar to Figure 10. Metallographic analysis performed on a typical cross-section of the rubbed specimen showed a relatively sharp groove in the ZrO_2 seal surface where the seal was rubbed, Figure 11. Microcracking of the ZrO_2 was observed along with particles of M-CrAlY (from the blade tip) below the rubbed surface. The presence of these M-CrAlY particles below the rubbed surface is an indicator of extremely high compressive stresses extruding metal from the blade tip into the porous zirconia seal material during the rub.

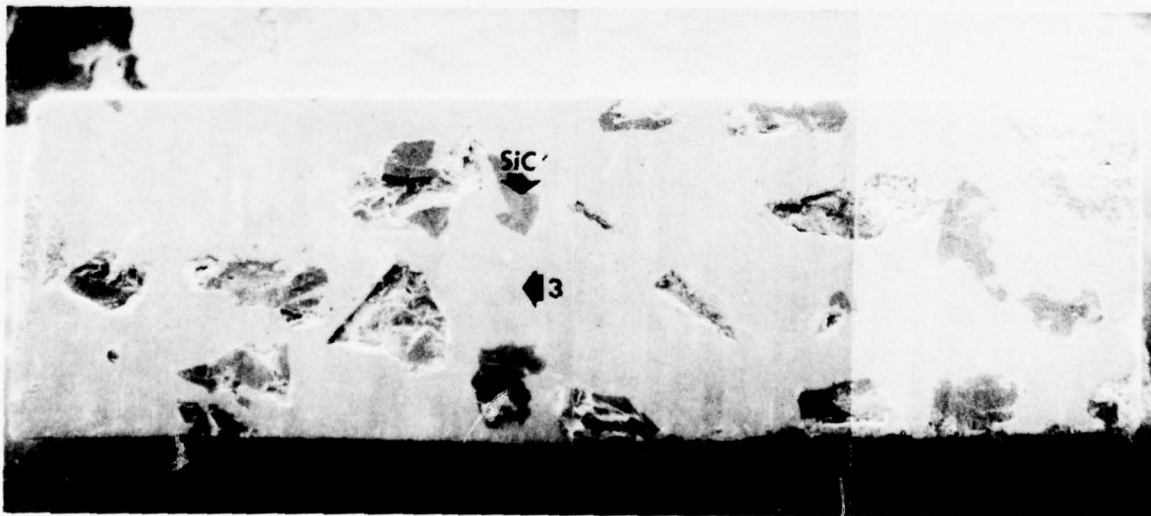
Figure 12 Rub Tested SiC/M-CrAlY Blade Tip. SEM Photograph at 18.7X

The tested SiC/M-CrAlY blade tip is shown in Figure 12. The SiC particles can be clearly seen in the tip structure. Wear of the SiC particles produces smooth wear flats with some fracture observed, most probably as a result of pre-test machining damage. A typical SiC particle wear surface showing a smooth wear flat was examined as indicated in Figure 12. The surface of the SiC particle was observed to have a layer of smeared material unevenly deposited on the surface, Figure 13. Dispersed x-ray analysis was performed on areas 1 and 2 of Figure 13. Area 1 analysis, Figure 13 showed the presence of minor quantities of M-CrAlY elements. Area 2 analysis, Figure 13, showed the smeared material to be composed of elements common to both the M-CrAlY material and the zirconia seal material. A typical region of metal M-CrAlY matrix material was also examined in detail located in Figure 14. SEM examination of this area showed a severely deformed surface comprised of extruded metal smears in the rub direction. Dispersed x-ray analysis of a typical smear showed the presence of elements common to the M-CrAlY, SiC and zirconia seal system.

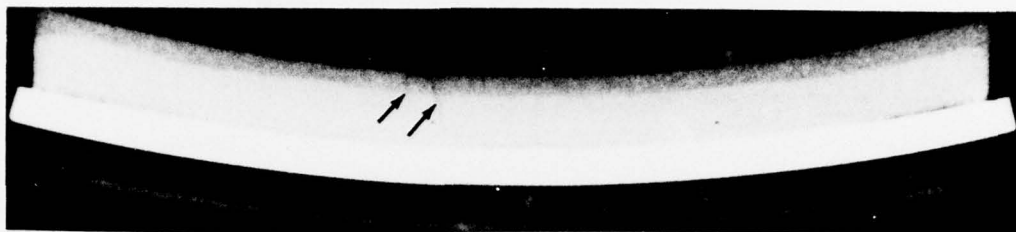
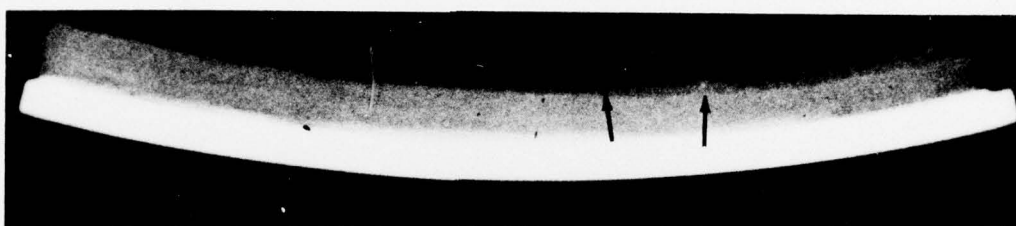
The results of the nondestructive inspection (NDI) testing by x-ray and visual methods are summarized in Table I to Table V for all iterations of the graded ceramic-metal seal design rig specimens. With x-ray inspection it was possible to detect the depths of visual cracks (Figure 1, x-ray a), degree of thickness uniformity of the ZrO_2 layer (x-ray b), local density variation (x-ray c) and layer separation (x-ray d in Figure 1).

Visually observable surface cracks in some of the ZrO_2 layer of the specimen were shown to terminate in the graded ZrO_2 -NiCr layer (Figure 1, x-ray a). These cracks were not considered to be critical.

Local density variations were observed (Figure 1, x-ray c). Areas of lesser density appear slightly darker than adjacent regions in the figure. When this specimen was later sectioned, one of the density variations was found to be associated with a void at the substrate interface and with some porosity within the ZrO_2 layer.

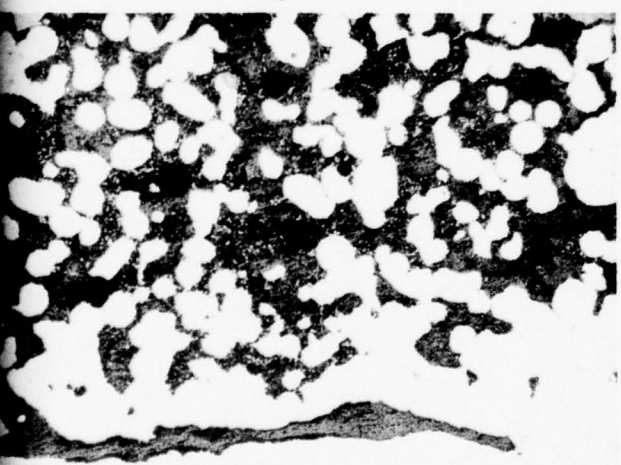
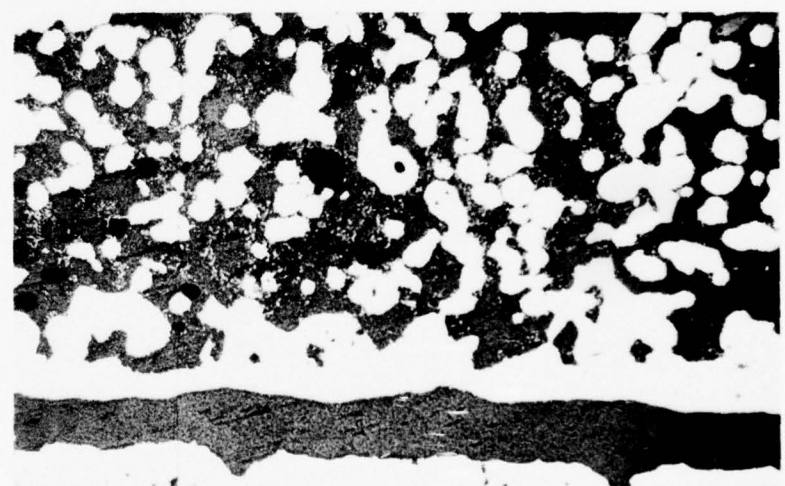
Figure 6 Microstructure at Planes 2a (Right) and 2b (Left) in Seal Sample D, Verifying the Ultrasonic Inspection Indications of Disbond at the Interface of the Graded ZrO_2 -NiCr Layer and the Substrate

Specimen 2 was sectioned in two areas to verify the ultrasonic disbond indications. Metallurgical examination at planes 2a and 2b clearly showed that the ultrasonic indications are associated with a separation between the graded ceramic-metal system and MAR-M-509 substrate (Figure 6).

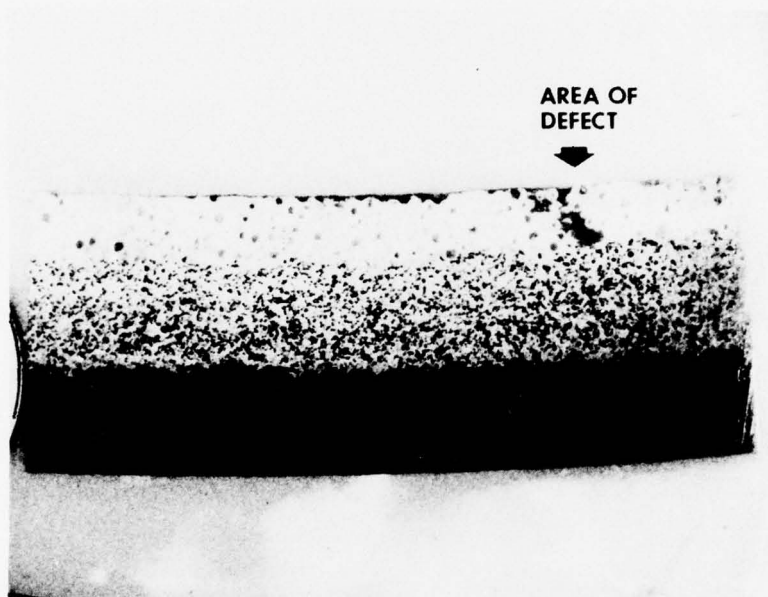
Figure 7 Metallographic Section at Plane 3a in Seal Sample 3 Showing Density Variations in the Graded ZrO_2 -NiCr Layers; Variations Had Been Detected by X-Ray

Specimen 3 was examined to characterize the density variations shown by x-ray. The metallographic section (Figure 7) shows a void near the metal substrate approximately 0.140 inch long. A low density area in the ZrO_2 layer is located almost directly above the void.

It is concluded from the results of the metallurgical examination of specimen 3 that x-ray techniques will be able to distinguish three types of defects not observable by visual inspection: (1) nonuniformity of ZrO_2 layer thickness, (2) separation of the graded ceramic-metal system from the substrate, and (3) porosity within the graded ceramic-metal system. It is also concluded that ultrasonic inspection is capable of distinguishing unbonded regions of the specimens which x-ray may not indicate because of lack of sufficient separation between the graded ceramic-metal system and the metal substrate.

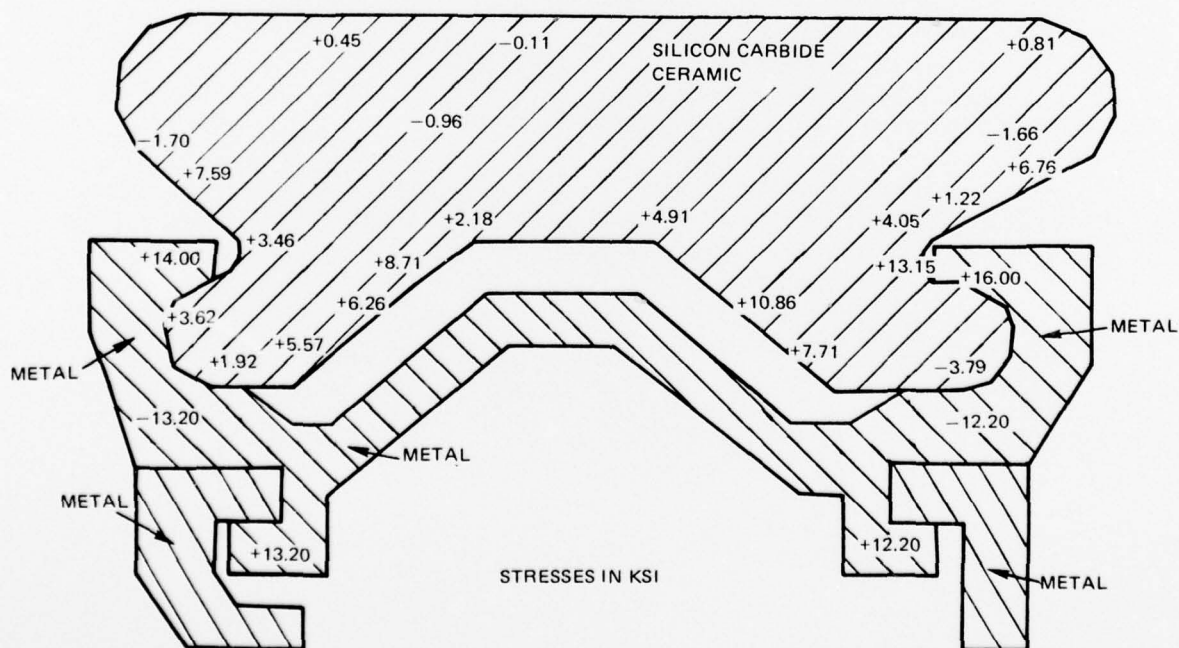
Figure 2 Stress Map of "First" Advanced Engine Structural Ceramic Turbine Seal Design

The principal difficulty encountered in the structural ceramic seal analysis is in the area of distortion and leakage. The thermal gradient in the metal at the SiC-metal attachment location is 300°F per inch. The circumferential stress of the quarter-segment design proposed was found to give an unacceptable radial distortion of approximately 150 mils. To reduce the distortion to an acceptable level would require increasing the number of segments, which would increase the potential leakage.
